# GMC Motorhome Parking Brake Deficiencies and Improvements

HOW ABOUT A GMC PARKING  
AND EMERGENCY BRAKE ?

# Objective

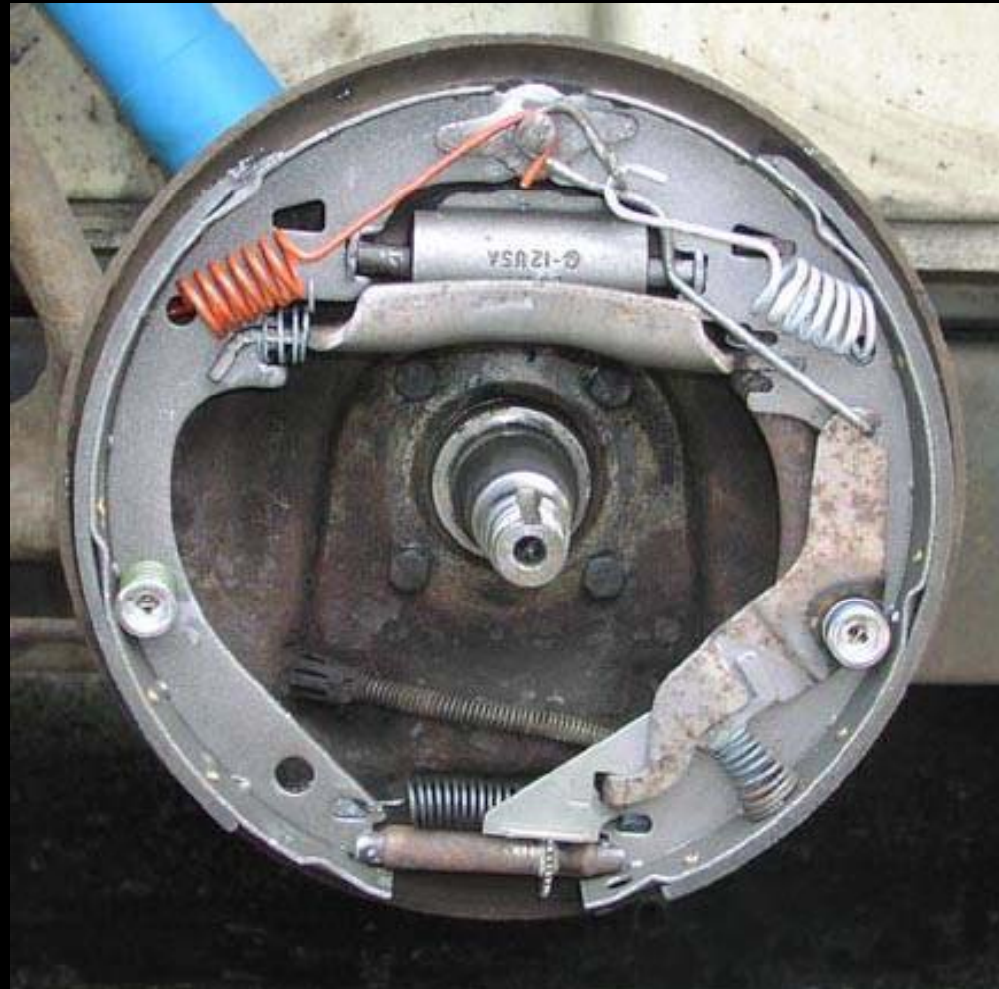
Brake Shoes :  
Two different types and two different widths as well as assorted friction materials.

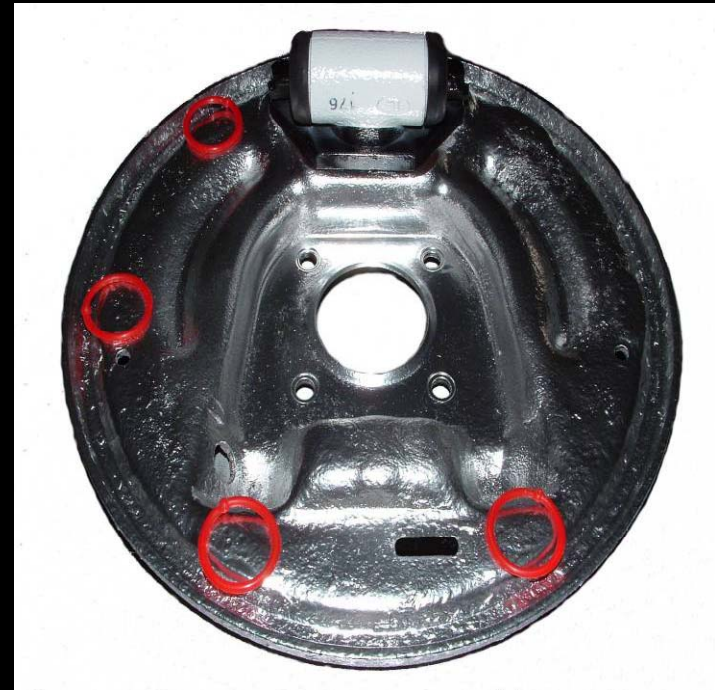
Blank backing plate

Over time these shoe wear pads take quite a beating, when installing new shoes carefully clean and inspect these pads, using a zirconia flap disc one can generally buff out the worst of the wear damage in severe cases the pads have been built up using brazing rod and buffed flat after , due to a new backing plate not being readily available. Ensure these pads are sparingly lubricated with never – seize or a similar compound .

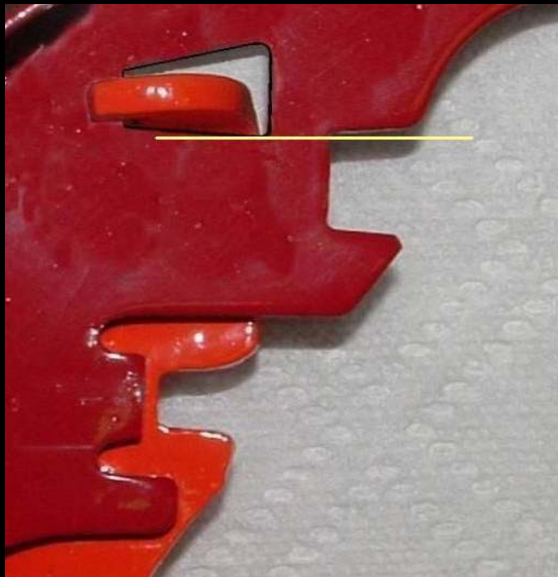
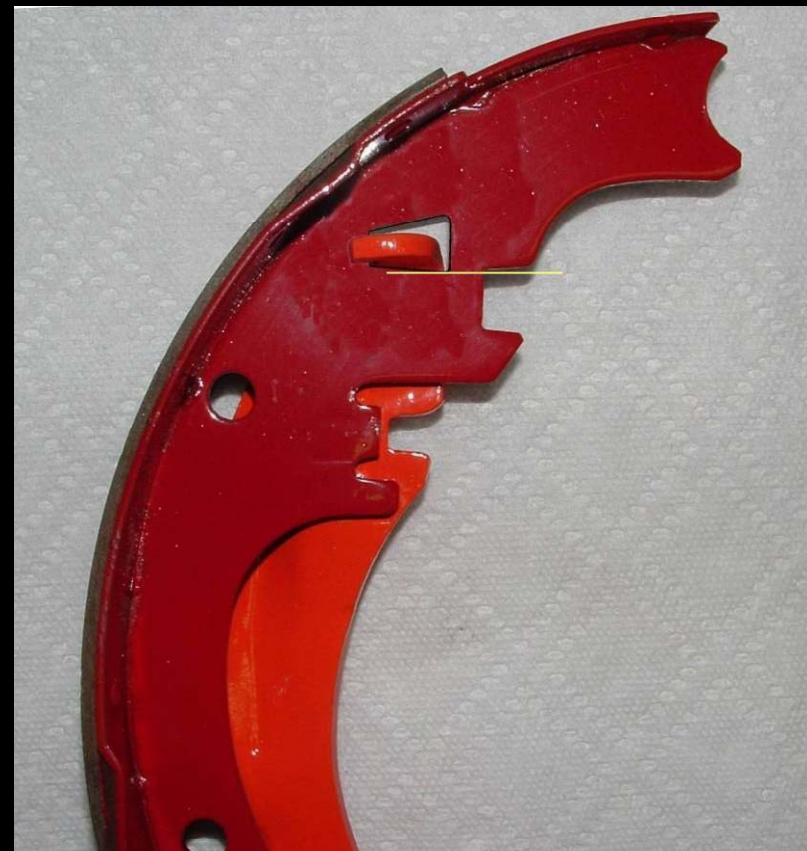
- Current shoe type #462 ( Low hole )

Note : bottom of park brake lever hole in line with top of piston pushrod notch

- Disregarding friction materials, there were two basic shoe configurations. The 1973 and '74 GMC used a shoe set originally designed for the 1969 Pontiac Bonneville S.W. , commonly referred to as a #272 , The park brake lever hole was very high up on the shoe web compared to the later and current shoe used on the 1975 thru '78 GMC's ; the #462 shoe was designed for the 1972 and '73 Pontiac S.W.
- GM essentially recalled all the 1973, '74 and a limited number of '75 rear brake assemblies and reissued completely loaded backing plates of the newer Pontiac vintage, ie. The #462 shoe set.

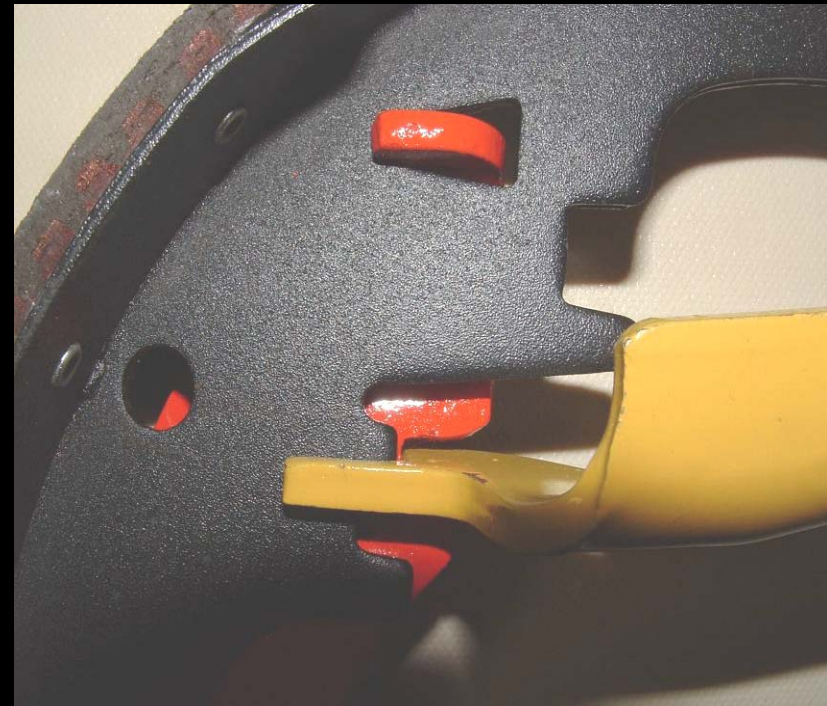
- Current shoe type #462 ( Low Hole )

**Note how tang on brake shoe aligns correctly with the notch in the park brake lever and that the horizontal strut is centered and level. This is a correct configuration**

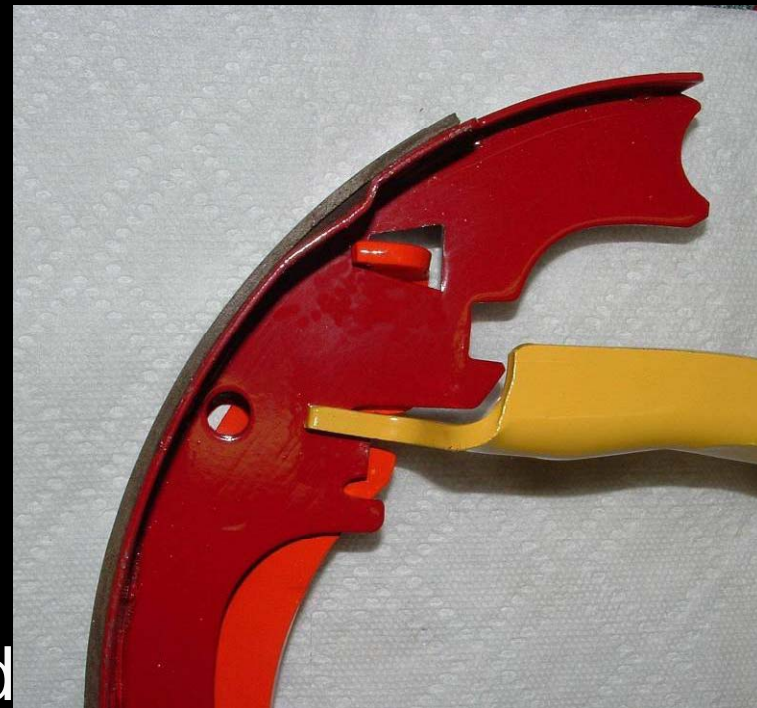
- This is a pre 1975 shoe ie. #272 with a post 1975 park brake lever, note the severe misalignment due to the high hole on the #272 shoe . This usually occurs when a new owner doesn't realize that GM recalled these assemblies in 1975.

- The pre '75 shoe and the current park brake lever is by far the most common mismatch. This type of mismatch will cause severe binding between the cross strut, the park brake lever and shoe. This will impair parking brake operation and to a lesser extent the operation of the service brake as well

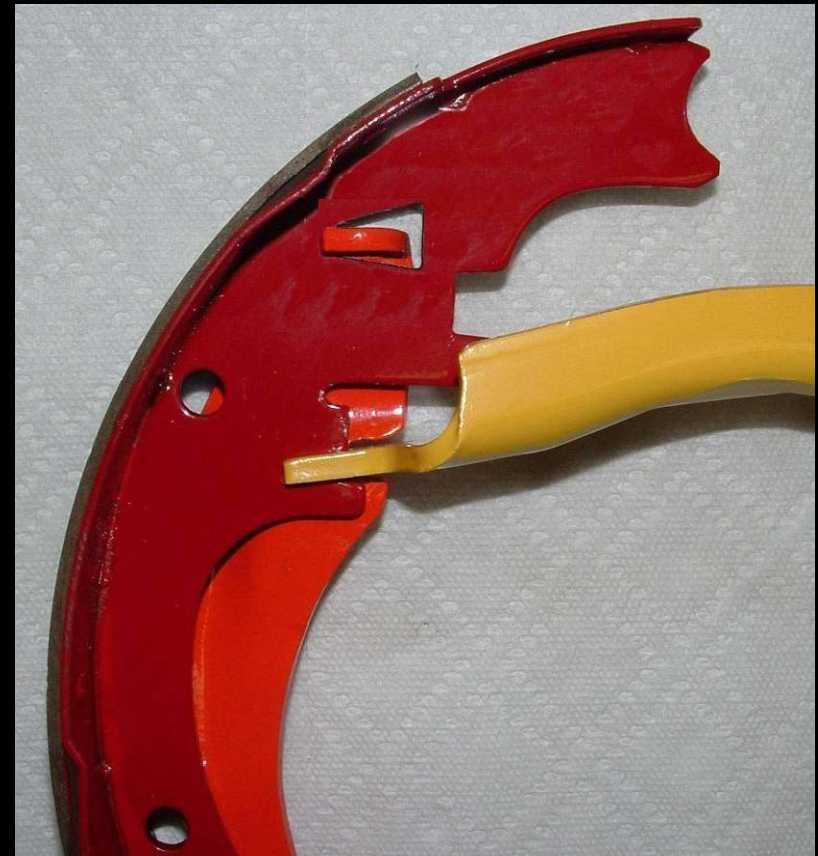
This is a post 1975 shoe ie. #462 with a pre 1975 park brake lever, again severe misalignment due to the lower hole on the shoe and a lever that's too long . This scenario would be very rare due to the recall on the old park brake levers and the inability to purchase new ones.

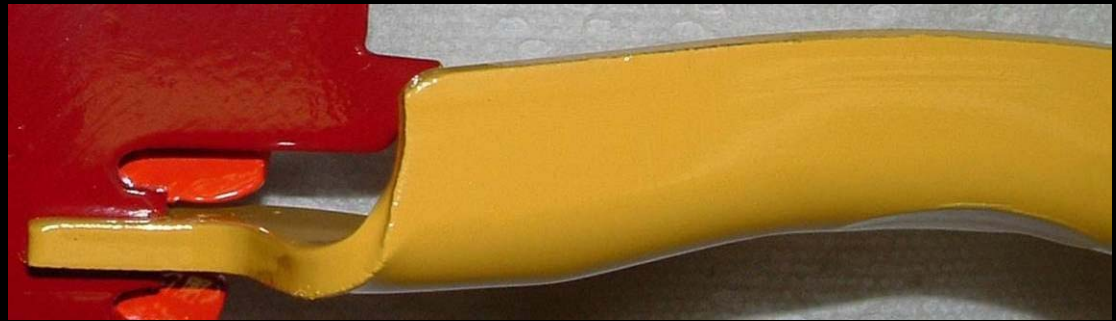
## Park Brake Strut:

- **Over time the cross strut will wear at both ends leading to excessive play in relation to the PB lever and brake shoe. This will translate to lost motion in the PB cable system. With the total handle travel distance limited to 2.375" , lost motion must be kept to a minimum. With the brakes properly adjusted ; the end play of the PB strut should not exceed 1/32" , replacement or building up the worn areas in the notches will be necessary if wear is excessive.**

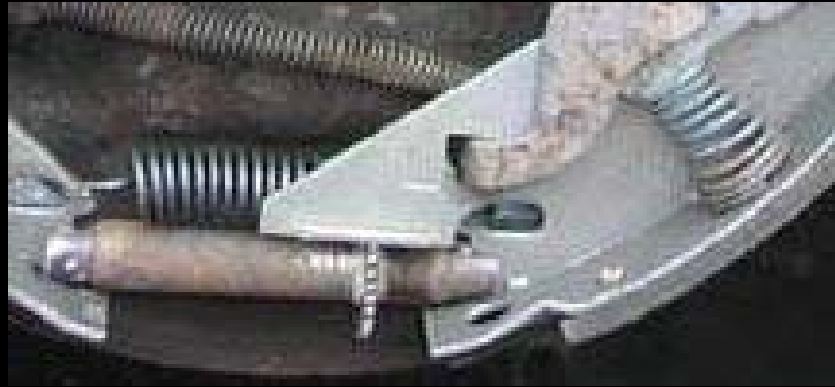
## Auto Adjusters:

- The auto adjusters will work if the coach is backed up with sufficient conviction and the brakes are sharply applied. However the "significant other" will be less than impressed with the rearrangement of the cupboard and fridge contents. **THUS:** Manual adjustment is strongly advised whenever the brake pedal travel approaches halfway.

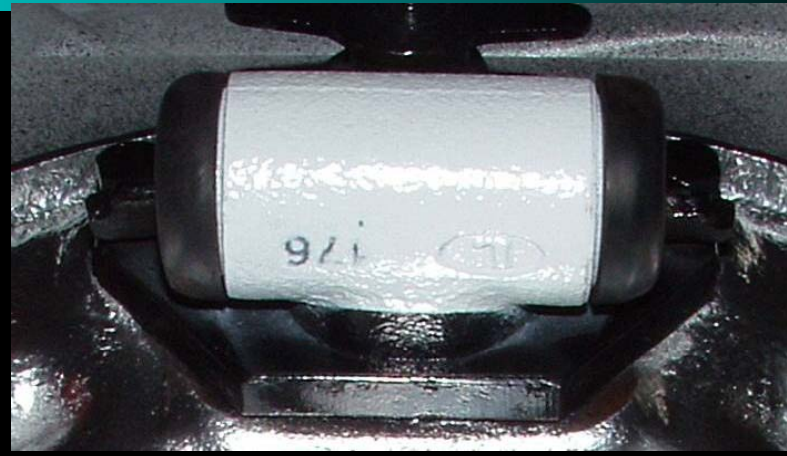
# Backing plate wheel cylinders

- Check for any signs of fluid leakage , rubber boot damage and excessive wear of cylinder push rods.

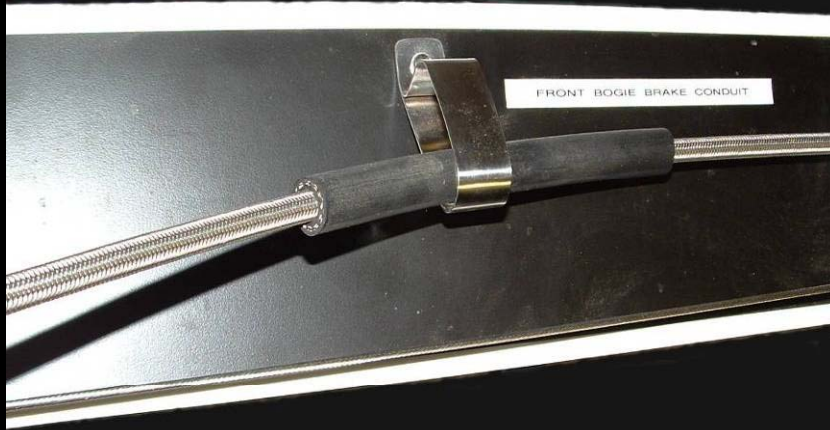
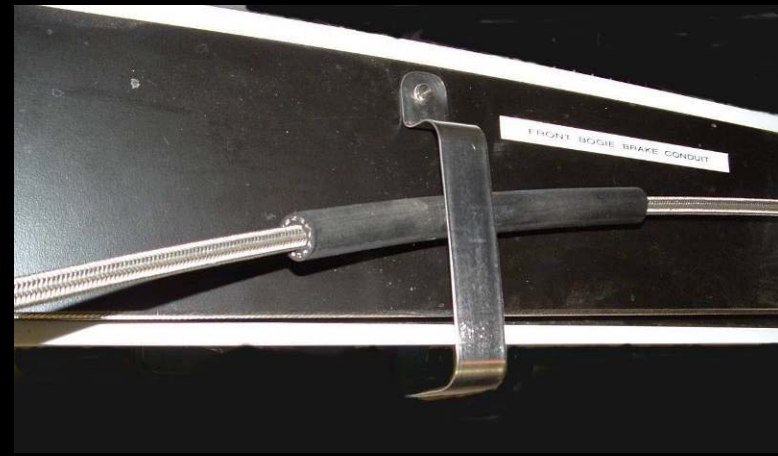
- Front bogie cable guide:

**OEM guide is extremely restrictive to the front bogie conduit movement. It should be modified to a similar configuration as seen in the photo on the right or removed completely.**

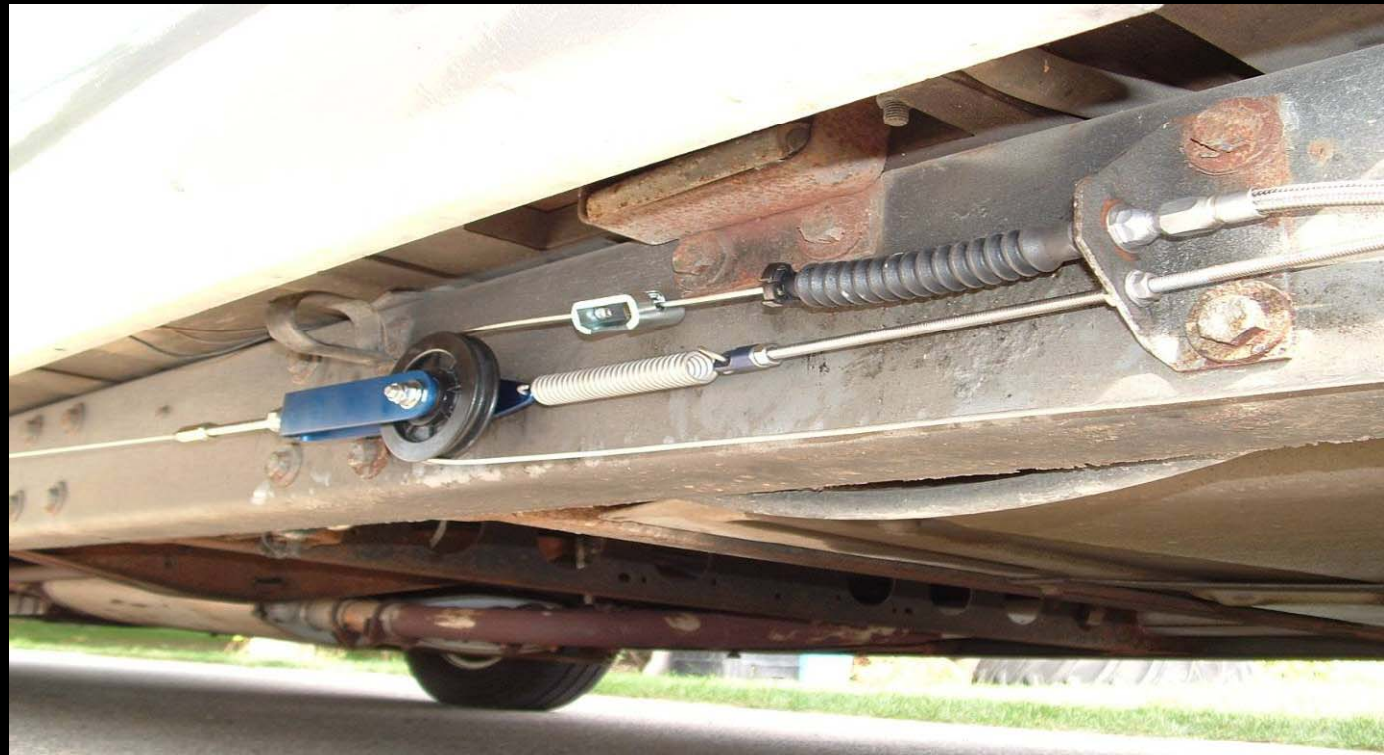
- Note the stainless return spring attached to the pulley yoke.

- To help prevent this problem a number of people have replaced the OEM equalizer with a suitable pulley and yoke assembly. There are a number of folk in the GMC community that sell these pulleys. One pulley possibility is the Stanley garage door pulley, it's about the right diameter. Just seal the small bearing against water and dirt.

- The intermediate cable retract springs avoid having to rely on the individual conduit springs to help pull back the intermediate and brake handle cable, thus ensuring positive release of brake shoe tension when the PB handle is released. Together the two stainless springs apply about 35 lbs. pull back force on the above cables.

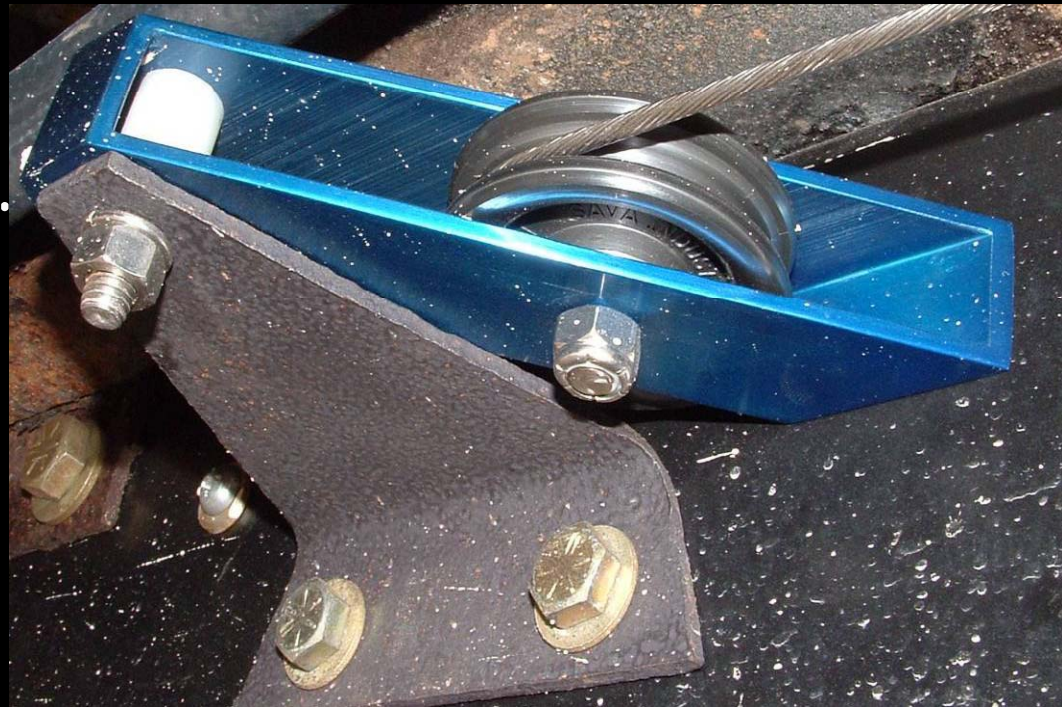
One of these pulleys on each side of the coach to replace the old "S" hooks.

- Pulley is Replacement for the OEM S-hook, pulley mainly added for strength

ANODIZED ALUMINUM " THRU-FRAME" ROUTING PULLEY.  
( Replacement for OEM Hook)

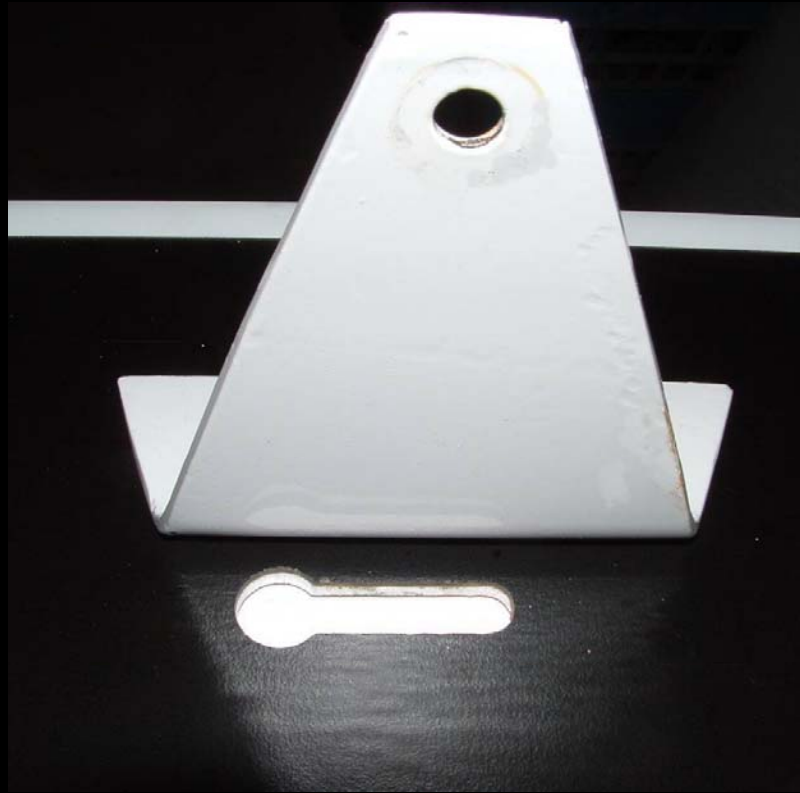
- The keyhole slot in the frame is to provide clearance for the union on the intermediate cable. The OEM slot is approx. 3/8" in height , whereas the new slot is 9/16" in height.

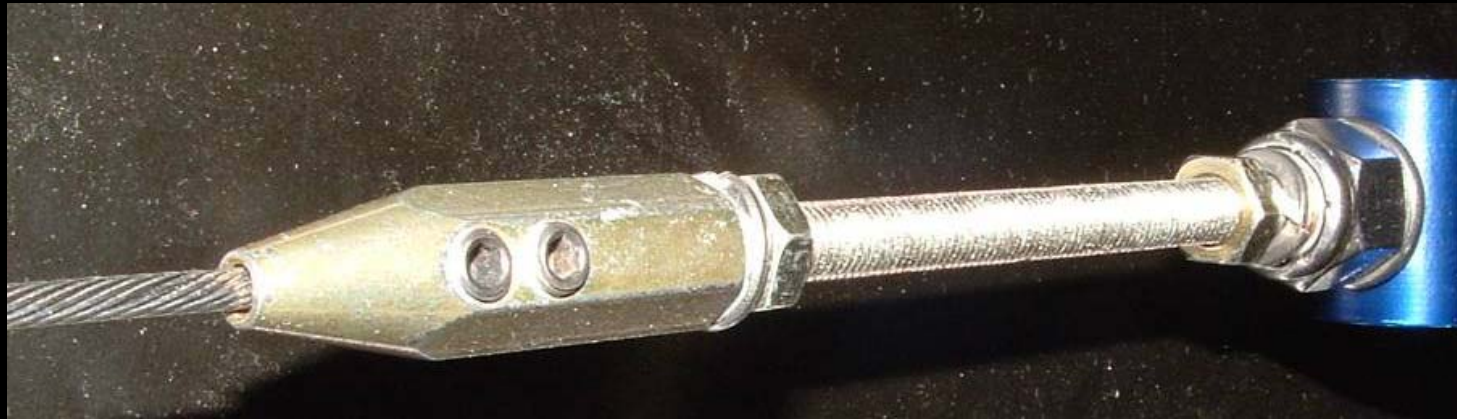
- This union is **not** to be taken apart. A stainless steel cylinder has been swaged onto the cable inside the union to supplement the strength of the two 1/4" Allen set screws.

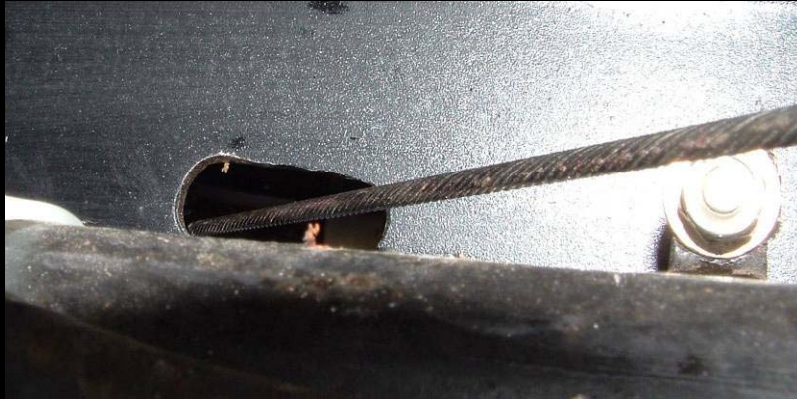
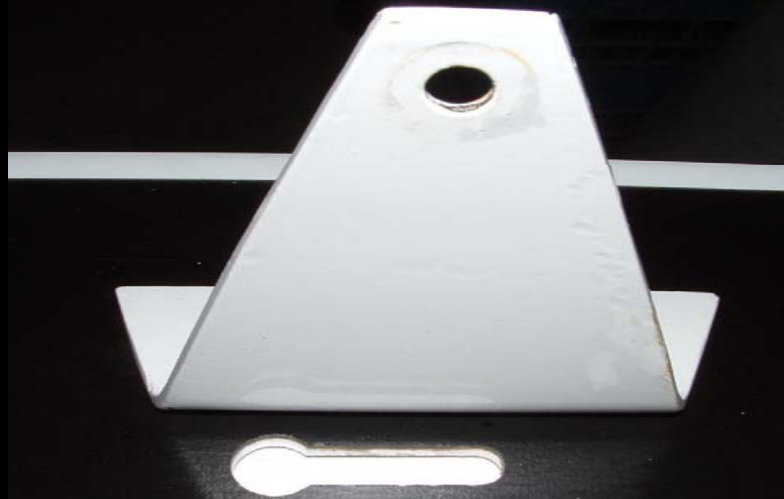
# Thru – Frame Routing Pulley

- **But all is not lost !** When you buy a new frame from the " Frame Doctor" the enlarged slots are included absolutely free of charge !

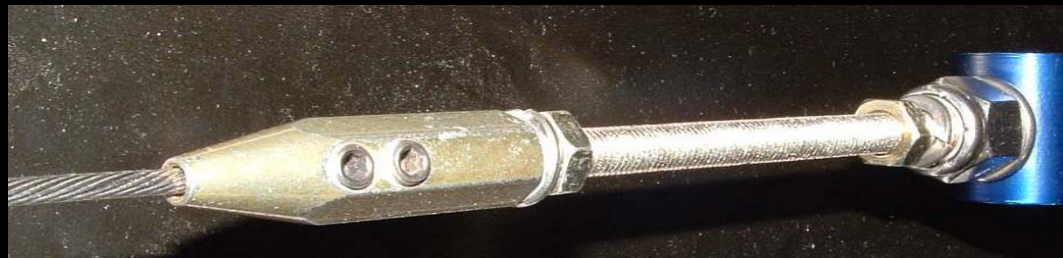
Intermediate  
Cable union

- The OEM intermediate cable was supplied in two lengths , to accommodate the 260's and the 230 coaches as well. Presently there is only one length available to the best of my knowledge. If you own a 230 coach be prepared to tie a few knots in the cable to shorten it up by the required 40 inches. However the new stainless steel intermediate cables come in both lengths !

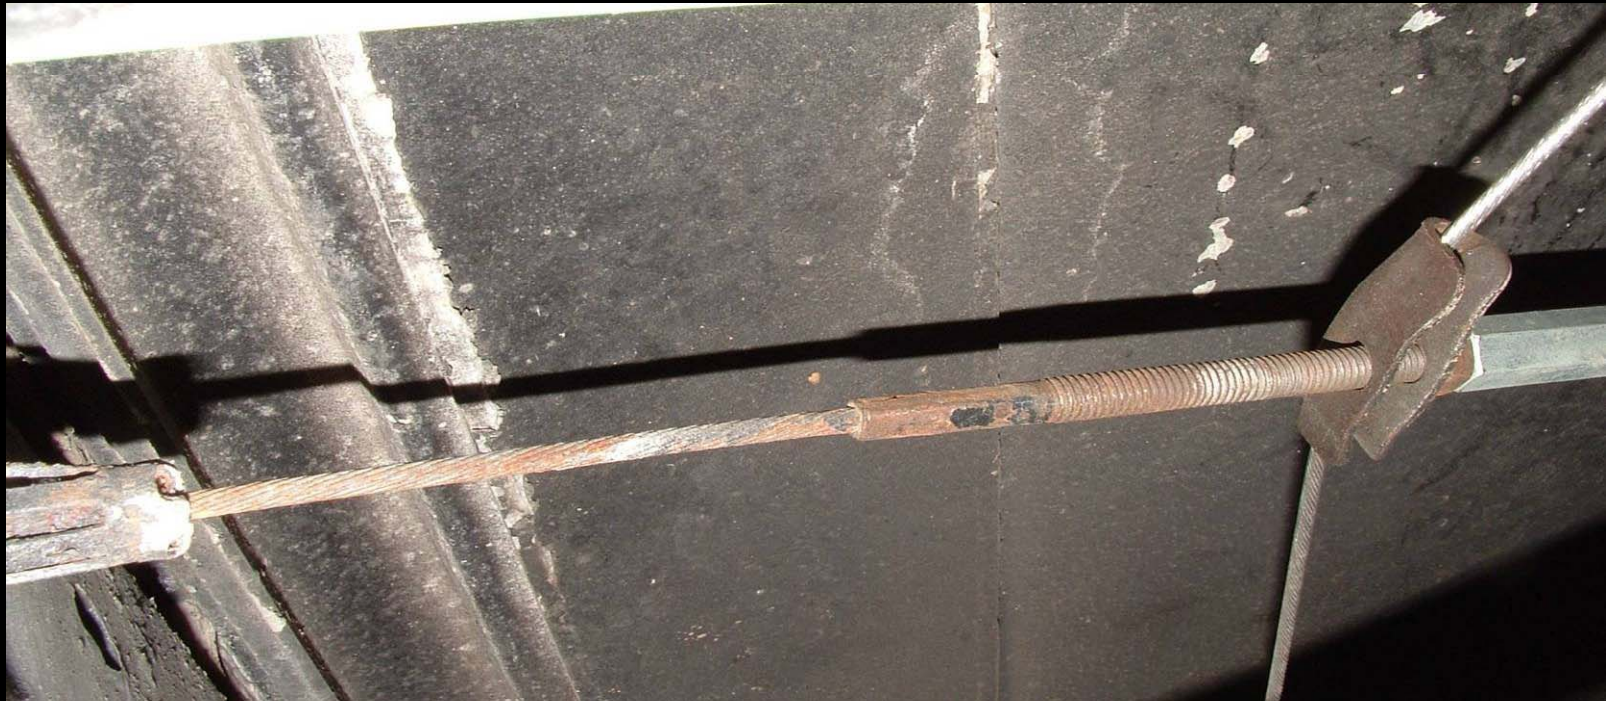
- OEM equalizer to connect intermediate cable to park brake handle cable

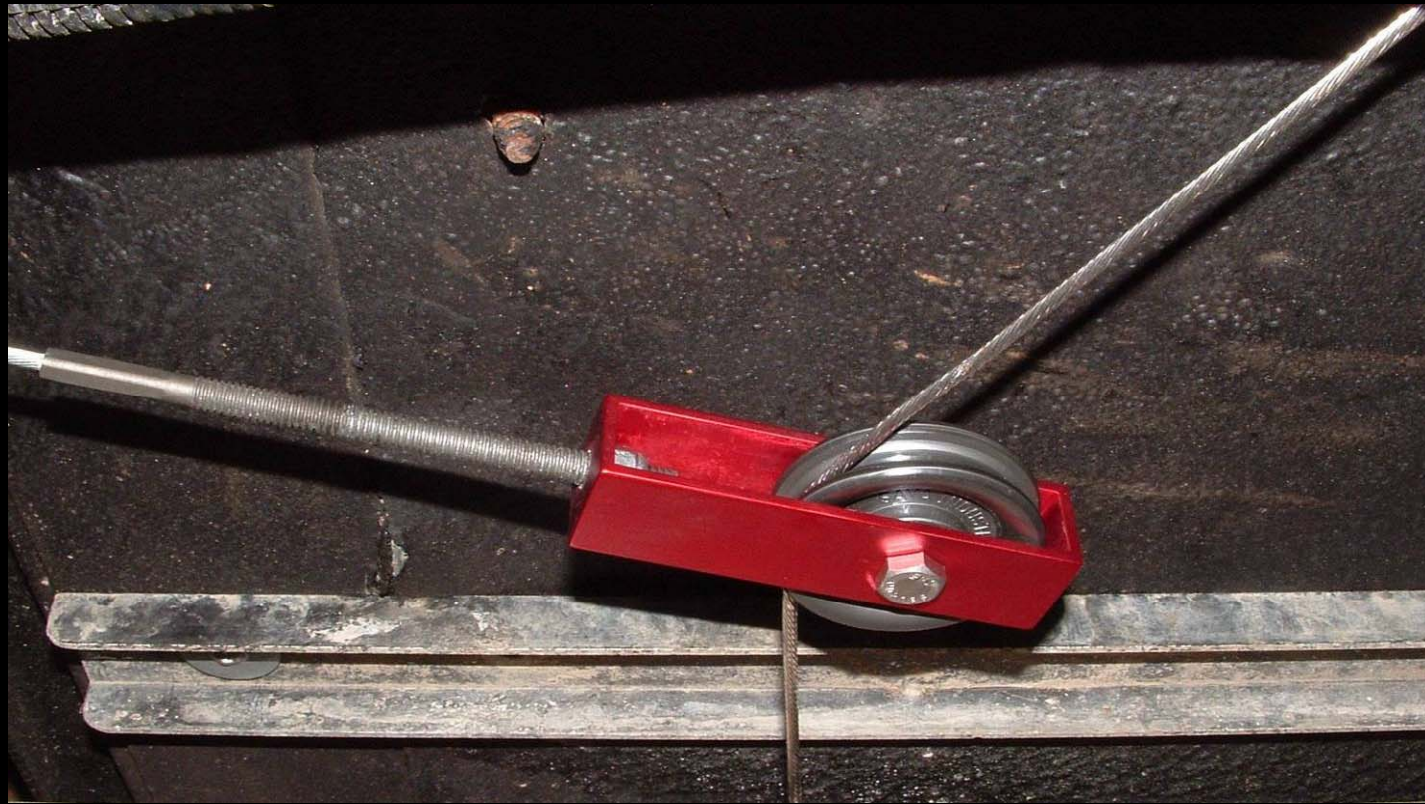
**Will balance left and right pull forces to less than 10 % , a 2 to 3 times improvement over OEM Eq.**
